Aging Infrastructure of America's Dams

Imaging sonar for dam assessment surveys:

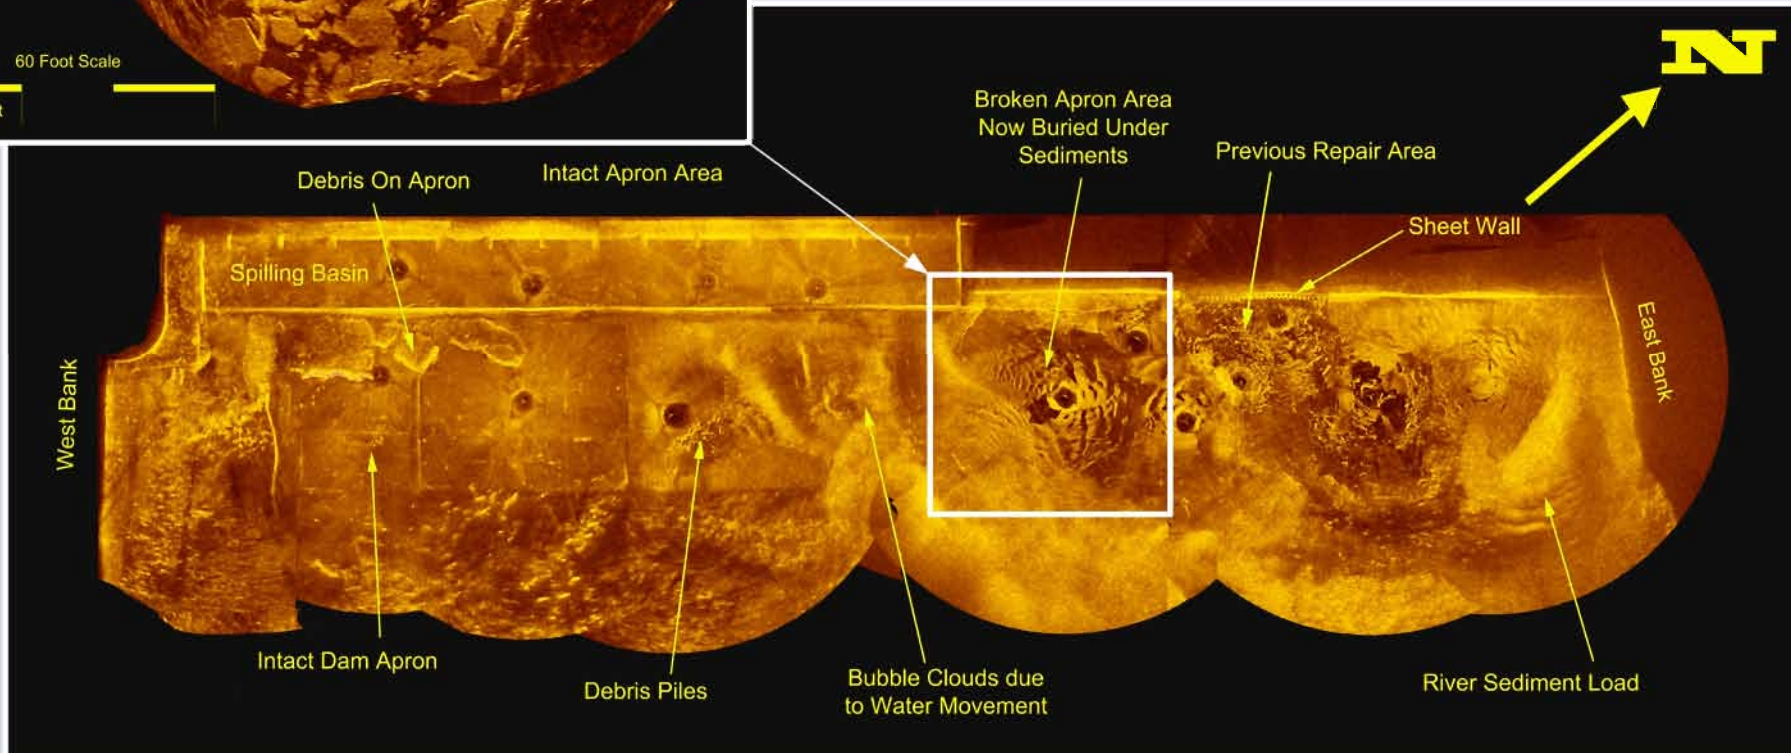
The data on this page shows the results of two scanning sonar surveys of a mid-western US dam. The first survey revealed structural failure of the dam apron concrete due to hydraulic river flow. Concerned about causing further damage, the dam authority diverted the water away from where the concrete failure occurred. The time cycle between surveys was 6 months. The lower image from the second survey shows sediment aggregation in the damaged area.

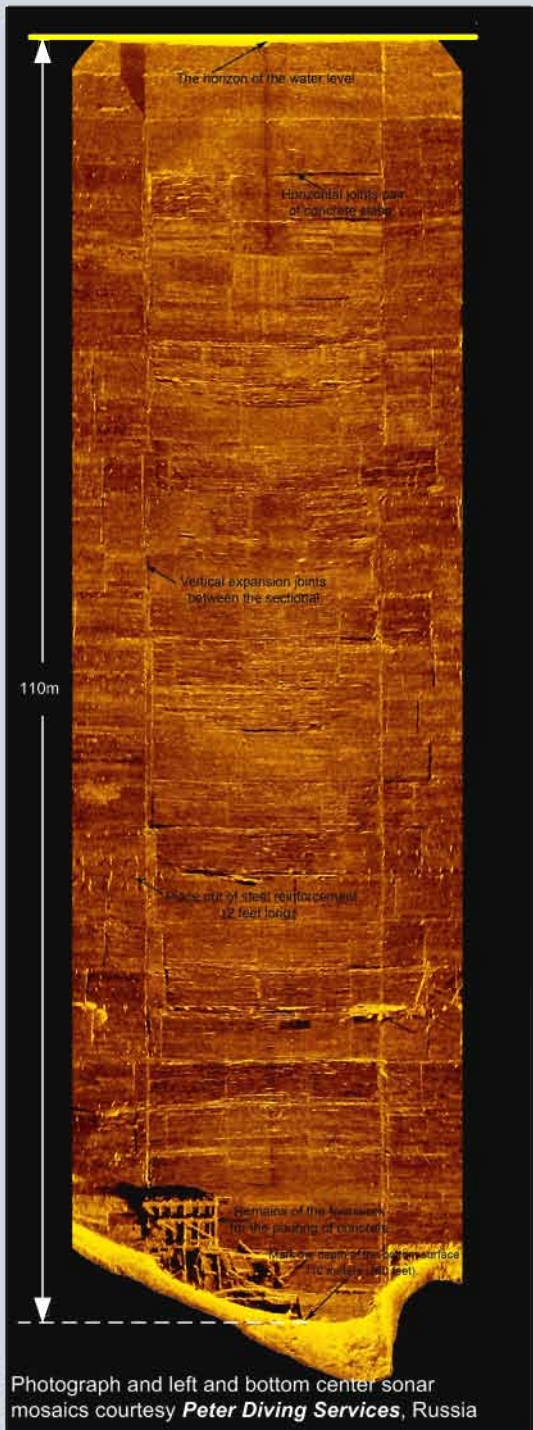
The photograph of the custom-built frame shows how the Kongsberg Mesotech Ltd., High Resolution sonar head was ROV-deployed to collect the left and center images. By pushing the frame against the vertical face of the dam, the ROV pilot kept the sonar head standoff distance identical for all scans.

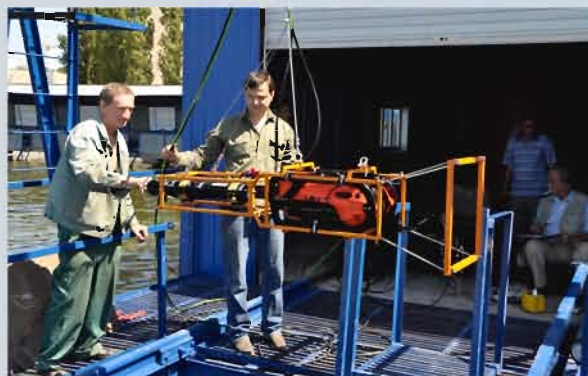
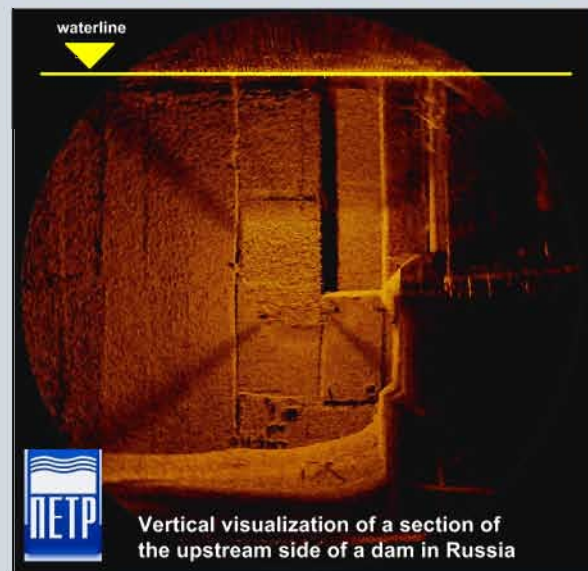
Vertical visualization of a section of the upstream side of a dam in Russia

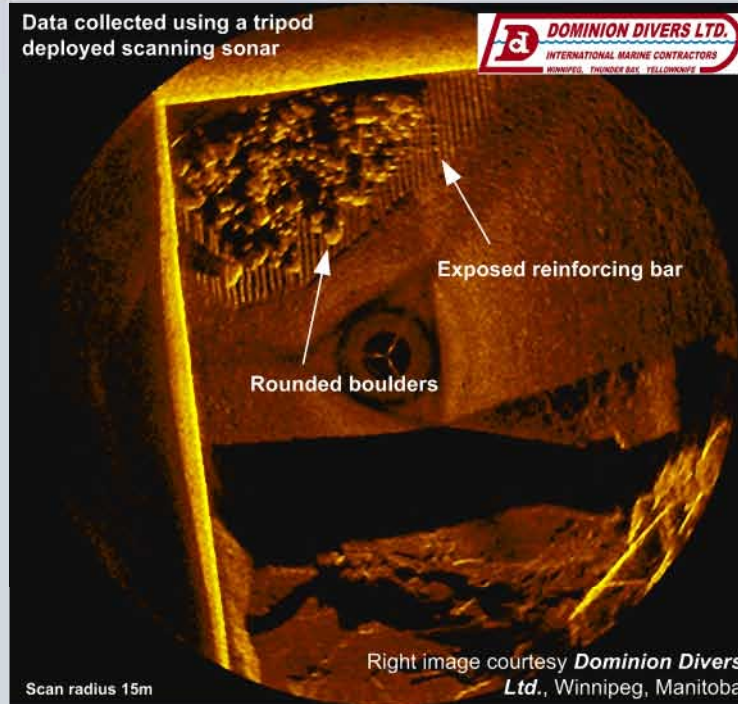
The right sonar scan shows a corner section of the downstream dam apron and a condition known as “Ball Milling.” This is the result of rock boulders being hydraulically trapped due to the structure’s shape and where the current rolls them against the concrete. The rocks become rounded (ball-like), and in this case, they have worn the concrete surface to where 5.08cm (2”) reinforcing bar is exposed.
