To: DPS 122/132/200/232/700 Users

Subject: DPS version 7.01.04

Release Note

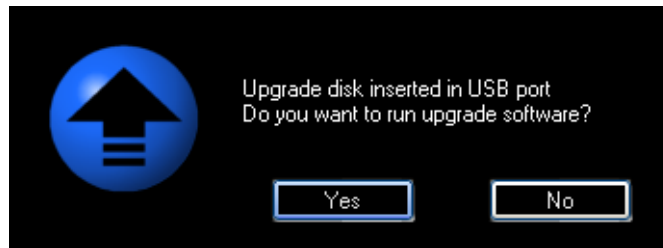
Figure 1 Software upgrade dialog

7 The following message will appear in the upper left corner of the screen:

Note On versions prior to 6.04.00, the upgrade dialog does not always appear in front of the DPS operator SW window. Restarting the Operator SW will make the upgrade dialogue visible.

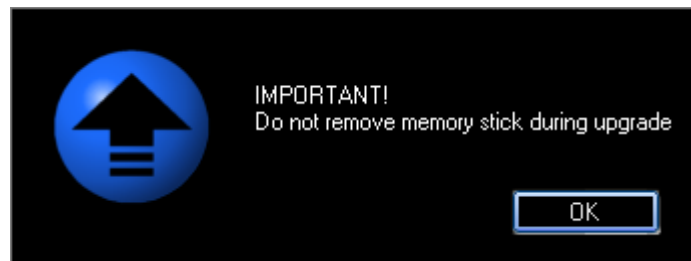
Figure 2 Information message

9 The following message is displayed:

Caution If the memory stick is removed before prompted by the system, the upgrade will fail and leave the DPS system in an indeterminate state!

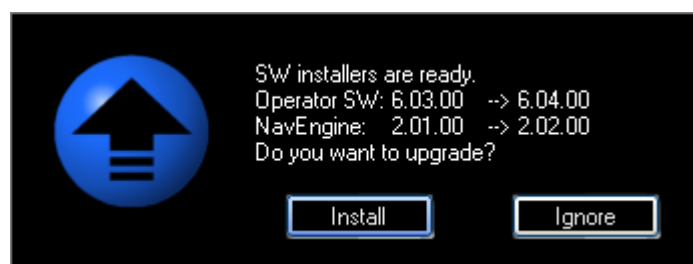
Figure 3 Version information

10 The upgrade system will now inform about the versions involved, as indicated in the following figure:

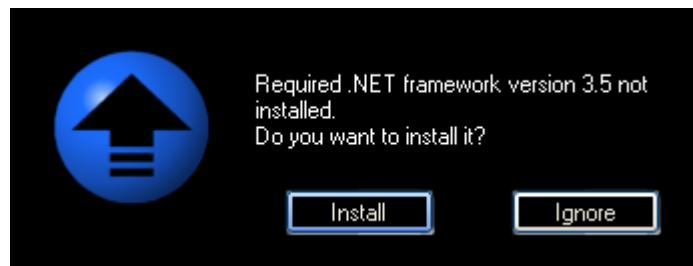
Figure 4 .NET framework required

- 13 A .NET framework upgrade is needed when upgrading from DPS versions 5.x. This is indicated in the figure below. Continue from step 17 if this dialog is not displayed.

Caution Ignoring the .NET framework installation request will cause no software to be upgraded, as the Operator SW depends upon this version of .NET framework.

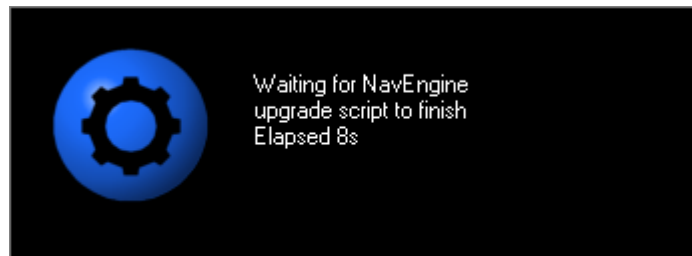
Figure 5 NAV Engine upgrade status

- 14 If the required .NET framework installer is *not* available on the memory stick, the installation will stop and a dialogue will appear indicating this. The system will resume normal operation, as no changes have been made at this point.
- 15 A dialog indicating that the .NET framework is being installed will appear. The installation will require around 10 minutes.
- 16 As soon as the correct .NET framework is available, the installation continues.
- 17 DPS software installation will now start, and progress information will be updated in the dialogue throughout the process. The Operator SW is upgraded first. Upon successful upgrade of the Operator SW, the NAV Engine upgrade starts.
- 18 The NAV Engine software and configuration will now be upgraded. NAV Engine upgrade status is indicated.

Note If the GNSS receiver FW is to be upgraded, the NAV Engine upgrade may take up to 20 minutes. Do not under any circumstances interrupt the upgrade. This may damage the GNSS receiver.

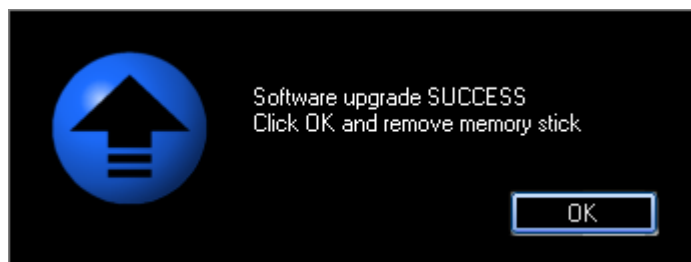
Figure 6 Successful installation

- 20 When the software upgrade has been successfully installed, the message below is presented. Click **OK** and remove the memory stick.
