To: DPS 4D Users
Date: 2012-03-30
Subject: DPS 4D version 1.02.01

HMI Version 6.08.04

NAV Engine Version 2.00.01

Release Note

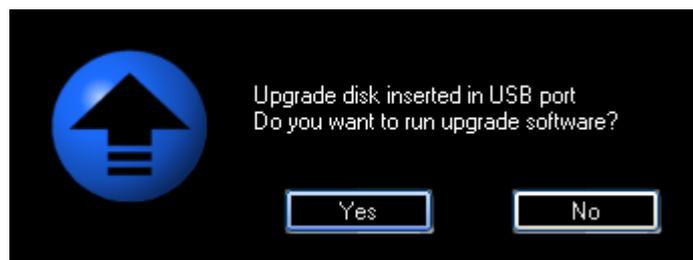
- 1 Perform a system configuration backup by selecting **Copy configuration** from the **Tools** menu. It is recommended to run this program twice; once with a memory stick as the target and once with a folder on the DPS hard disk as the target.
- 2 If you have received a DPS system upgrade memory stick from Kongsberg Seatex, please continue from step 4.
- 3 Extract the contents of the zip file received from Kongsberg Seatex to the root folder of a USB memory stick. Verify that the memory stick contains a folder named DPS in the root directory after extraction.
- 4 Insert the upgrade USB memory stick to a USB port.
- 5 The following message will appear in the upper left corner of the screen:

Figure 1 Software upgrade dialog

- 6 Click **Yes** to run the software upgrade.
- 7 The following message is displayed:

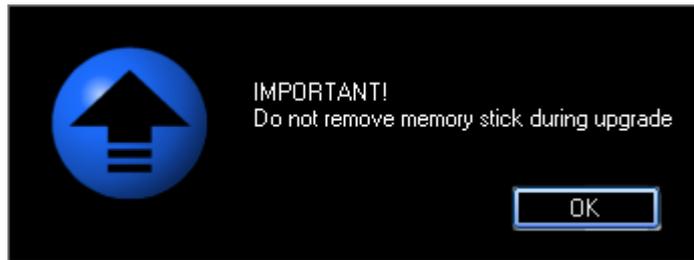
Figure 2 Information message

Caution *If the memory stick is removed before prompted by the system, the upgrade will fail and leave the DPS system in an indeterminate state!*

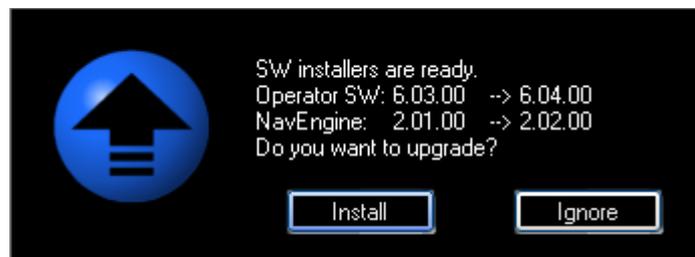
8 The upgrade system will now inform about the versions involved, as indicated in the following figure:

Figure 3 Version information

9 Click **Install** to start the upgrade.

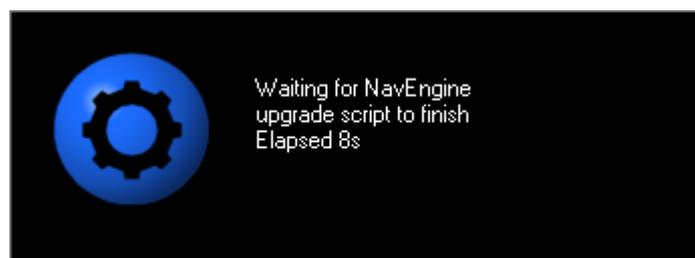
12 The NAV Engine software and configuration on the Processing Unit will now be upgraded. NAV Engine upgrade status is indicated as shown below:

Figure 4 NAV Engine upgrade status

The four LEDs on the Processing Unit's front panel will start flashing yellow during NAV Engine upgrade.

Note *If the GNSS receiver FW is to be upgraded, the NAV Engine upgrade may take up to 10 minutes (500 seconds). Do not under any circumstances interrupt the upgrade. This may damage the GNSS receiver.*

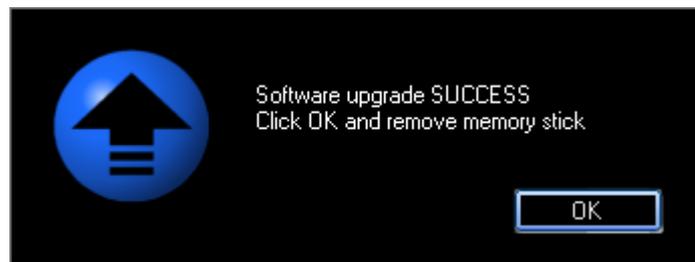
- 13 When the software upgrade has been successfully installed, the message below is presented. Click **OK** to close the dialog.

Figure 5 Successful installation

- 14 Remove the memory stick.
- 15 The Processing Unit will automatically reboot if required.
- 16 The system software is automatically started and output to external systems will resume.
